Re: Summer 2022 Capital Projects and 3-Year Master Facility Plan

Recommended Summer 2022 Capital Projects

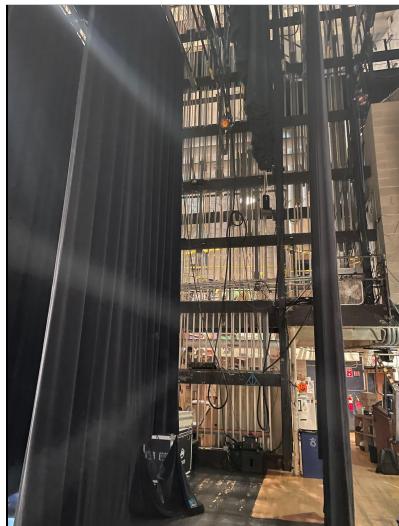
Image 2

Arbor Guide Wall with manual counterweight system controlling 23 of the 25 battens on Stage Left.

Location(s)	Project Description	Projection
GBS	<p>Auditorium Rigging System Replacement GBS has a manual, counterweight rigging system that is original to the auditorium (1961). This system provides the ability to lower and raise pipe battens by counterbalancing the load with an arbor loaded with counterweight (steel plates). There are 25, 76-foot long pipe battens that run across the stage's ceiling and are used to raise and lower theater equipment during a production.</p> <p>Breakdown of 25 pipe battens</p> <ul style="list-style-type: none"> 1 - Main Curtain batten 14 - General Purpose or Utility batten (scenery, special lighting) 4 - Legs (tall curtains on the side used to mask the sides of the stage) 3 - Lighting 2 - Travelers (full black curtains used as a backdrop for concerts etc.) 1 - Cyc (white curtain at the back of the stage used to project video or color) <p>Recommendations Twenty-three pipe battens are guided by a large grillage "Arbor Guide Wall" built on stage left and have a payload capacity of approximately 1,300 pounds per line set. It is recommended that these be replaced with a newer counterweight system. The grillage will remain.</p> <p>Two of the battens (Main Curtain and General Purpose) have counterweights on the opposite side of the stage. These counterweights are guided by free-strung wires, which do not comply with the newest ANSI standards and exceed the recommended travel distance. Due to the necessary placement of these line sets, they cannot be incorporated into the counterweight system on stage left. There is not proper height in this location to use a manual counterweight system. It is recommended that these be replaced with motorized battens. Rather than raising and lowering the battens through manual counterweights, these battens would be automated.</p>	\$440,000

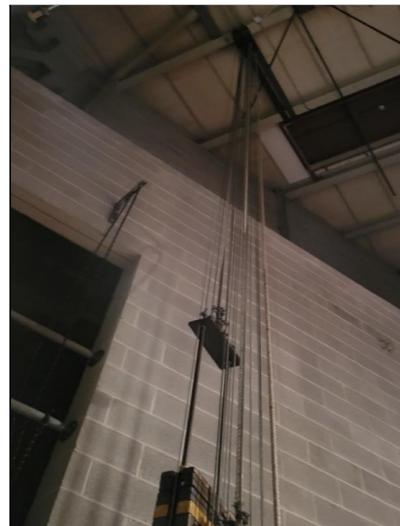
Image 3

Antiquated counterweight system controlling 2 of the 25 pipe battens on Stage Right.
