**Re:** Summer 2022 Capital Projects and 3-Year Master Facility Plan

**Recommended Summer 2022 Capital Projects**

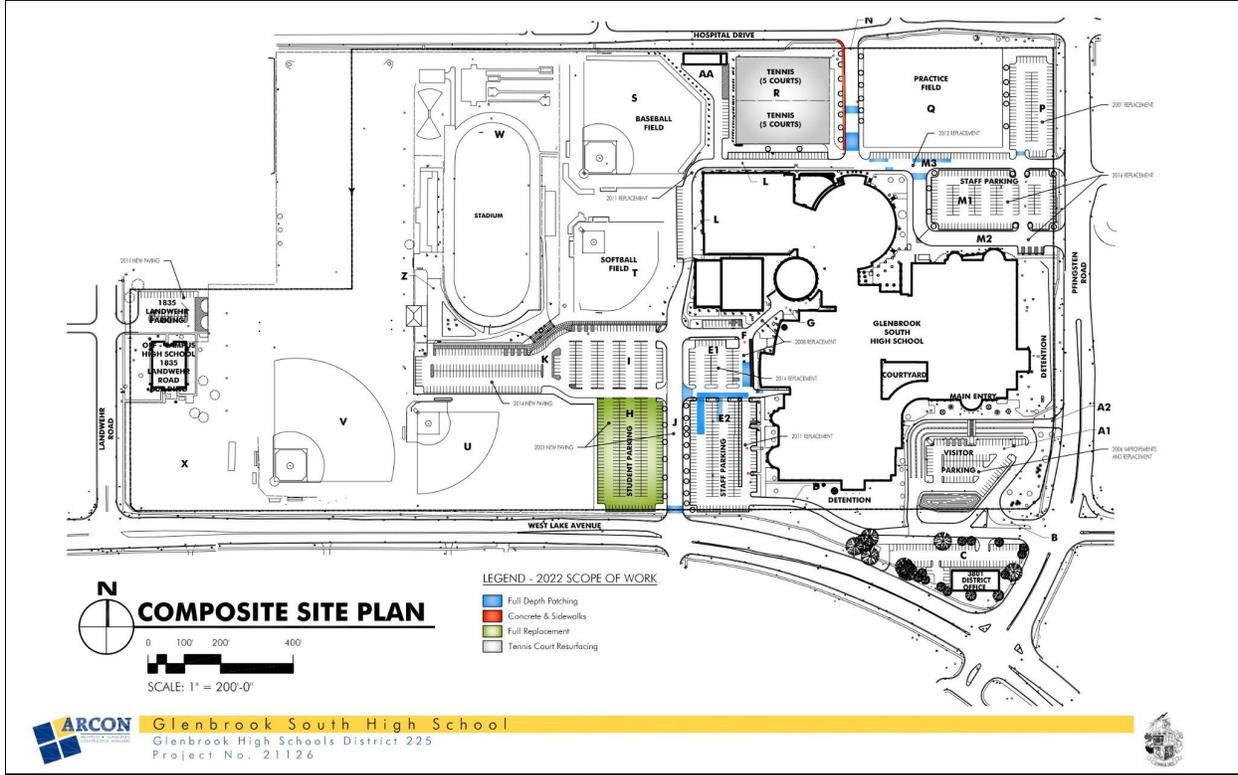
### GBS Site Work Map

| Location(s) | Project Description | Projection |
|---|---|---|
| GBS | <p><b>West Student Lot Replacement</b></p> <p>The district maintains a master paving schedule that plans for parking lot replacement every 15+ years and general maintenance (crack-fill and seal coating) every 4 years. The planned summer of 2022 work includes replacing the west student lot, which was last replaced in 2001, and is well beyond its useful life and showing signs of deterioration, such as alligator cracks, potholes, and crumbling, consistent with a parking lot of this age. The scope of work is to remove the existing pavement surface and binder course, remove the existing stone base and retain it on-site for reinstallation. In addition, core samples are being conducted to determine the extent of new material needed to supplement the existing stone base.</p> | \$335,000 |
| GBS | <p><b>Deep Patching</b></p> <p>As part of the annual parking lot inspection, several areas are recommended for full-depth patching, which involves saw cutting and removing the affected area and modifying the existing stone base to accept the specified asphalt pavement cross-section. This will lengthen the life of the parking lots.</p> | \$135,000 |

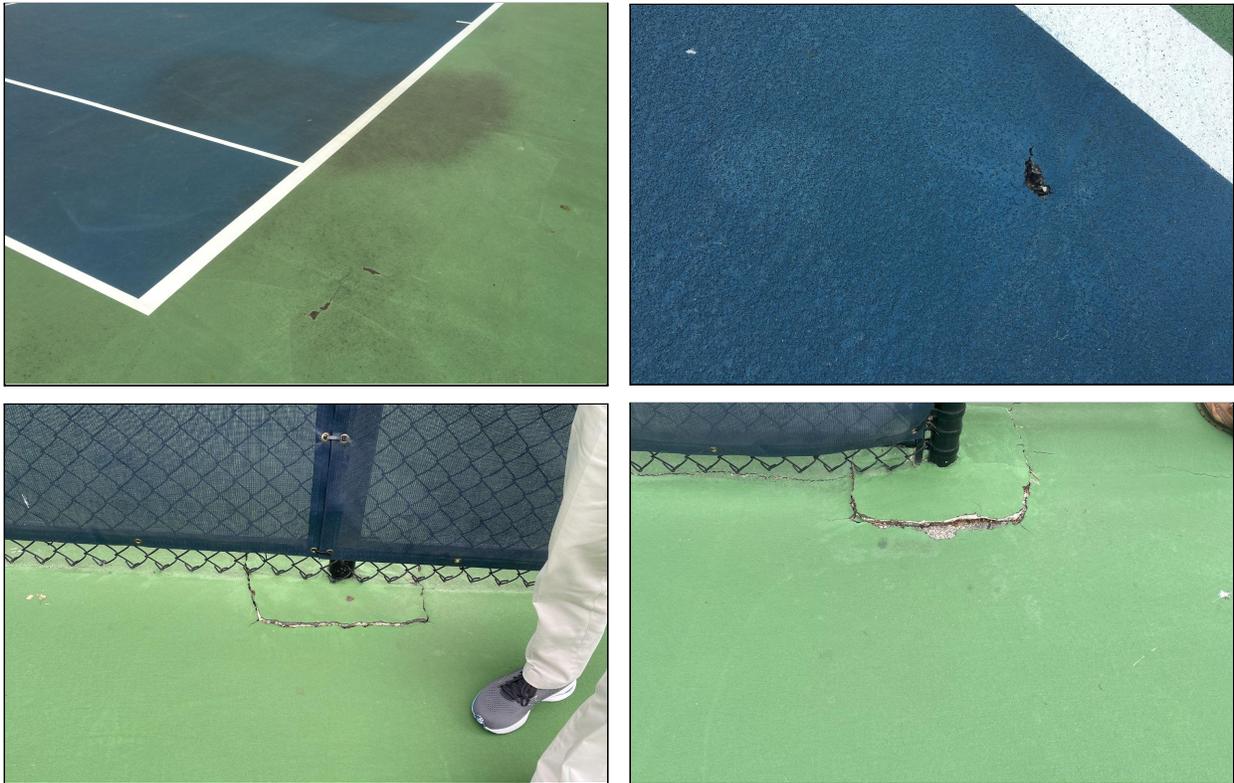
### GBS Tennis Court Images

| Location(s) | Project Description | Projection |
|---|---|---|
| GBS | <p><b>Tennis Court Resurfacing</b></p> <p>There are ten tennis courts at GBS that were last replaced in the summer of 2015. As part of an overall preventative maintenance program, a resurfacing procedure is recommended every 5-7 years to restore the court's playability factors and extend the life of the courts by preserving the integrity of the asphalt court base. This summer marks year seven, and the court is beginning to exhibit signs such as minor cracking, fading, discoloration, and ponding which are indicators they are due for resurfacing. Resurfacing includes filling all cracks, leveling low spots with sand-filled asphalt, and installing one coat of liquid resurfacer and two color coats. Additionally, fence posts are heaving due to the annual freezing/thawing process. Therefore, the raised edge of concrete surrounding the fence posts will be ground to give a smooth and uniform appearance. The sealant will be compatible with the liquid track surfacing and color coats. It should be noted that tennis courts are typically resurfaced twice in a lifetime.</p> | \$135,000 |

| Location | Project & Area | Description of concern and recommended action | Cost Est. Total | Summer 2022 | Summer 2023 | Summer 2024 | Deferred |
|---|--|---|---|---|---|---|---|
| GBS | Paving - Tennis Courts | The GBS tennis courts were last resurfaced the summer of 2015. It is recommended that they be resurfaced every 7 years. Work should be completed the summer of 2022. Crack repair and resurfacing will involve cleaning existing cracks and court surface, installation of "crack filler", filling cracks with granular silica sand, and applying one coat of acrylic resurfacer and two coats of fortified acrylic tennis court color coating surface.<br><br><b>Resurfacing of tennis courts recommended.</b> | \$135,000 | \$135,000 | | | |

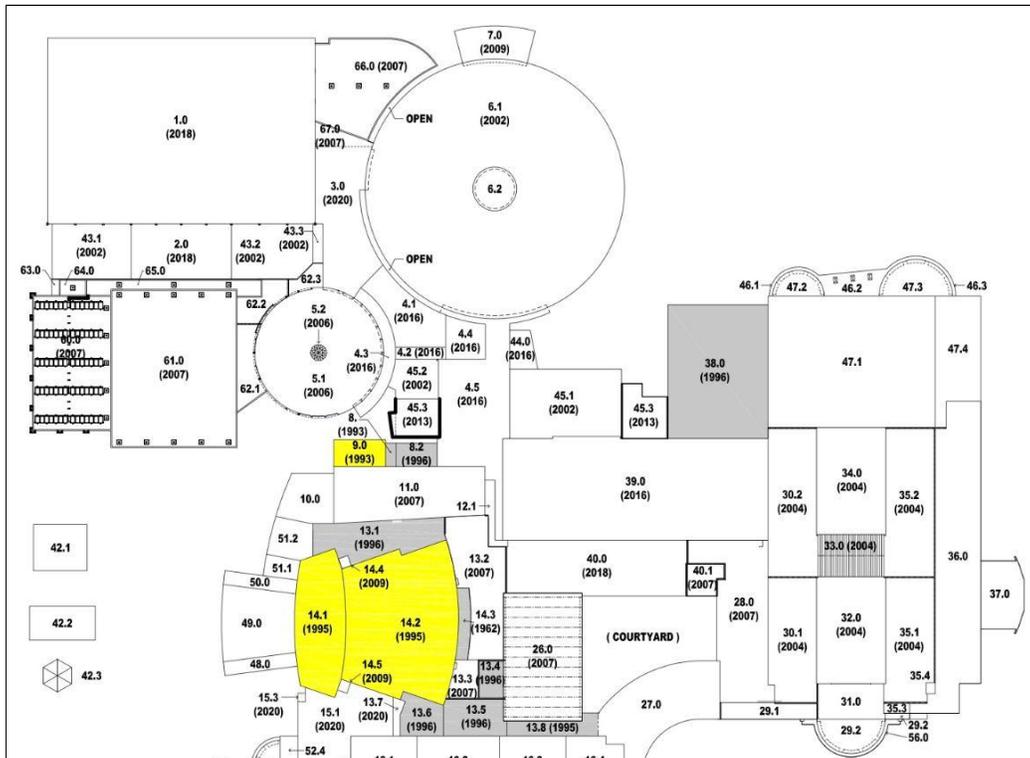
**GBS Roofing Map**

| Location(s) | Project Description | Projection |
|---|---|---|
| GBS | <p><b>Roof Replacement - Music (Records Room)</b></p> <p>The music records room roof is the oldest roof at GBS. It is 1,000 sq. ft. and was installed in 1993. This summer, it will be 29 years old and has reached the end of its serviceable life, demonstrating several deficiencies typical for this roof system's age. The proposed new roof system will consist of roof insulation with an R-value of 30.0 minimum and a multi-ply modified bitumen built-up roof membrane with gravel surfacing. Thus, the life expectancy of the new roof is 30+ years.</p> | \$35,000 |
| GBS | <p><b>Roof Replacement - Auditorium Stage</b></p> <p>The Auditorium Stage roof was installed in 1995 and is 5,400 square feet. This summer, it will be 27 years old and is experiencing several deficiencies typical for this roof system's age. The proposed new roof system would consist of roof insulation with an R-value of 30.0 minimum and a multi-ply modified bitumen built-up roof membrane with gravel surfacing. The life expectancy of the new roof is 30+ years.</p> | \$180,000 |
| GBS | <p><b>Roof Replacement - Auditorium House</b></p> <p>The Auditorium House roof was installed in 1995 and is 13,800 square feet. This summer, it will be 27 years old and is experiencing several deficiencies typical for this roof system's age. The proposed new roof system would consist of roof insulation with an R-value of 30.0 minimum and a multi-ply modified bitumen built-up roof membrane with gravel surfacing. The life expectancy of the new roof is 30+ years.</p> | \$460,000 |

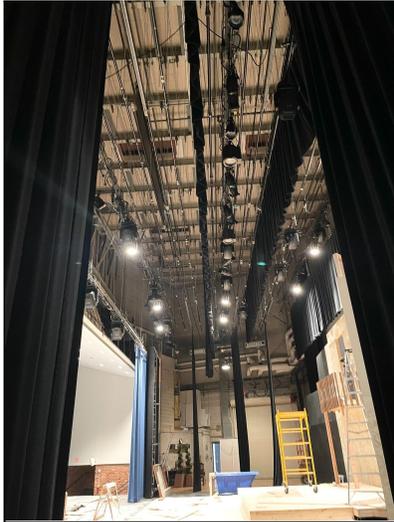
***Image 1***

| Location(s) | Project Description | Projection |
|---|---|---|
| GBS | <p><b>Auditorium Rigging System Replacement</b><br/>GBS has a manual, counterweight rigging system that is original to the auditorium (1961). This system provides the ability to lower and raise pipe battens by counterbalancing the load with an arbor loaded with counterweight (steel plates). There are 25, 76-foot long pipe battens that run across the stage’s ceiling and are used to raise and lower theater equipment during a production.</p> <p><b>Breakdown of 25 pipe battens</b><br/>1 - Main Curtain batten<br/>14 - General Purpose or Utility batten (scenery, special lighting)<br/>4 - Legs (tall curtains on the side used to mask the sides of the stage)<br/>3 - Lighting<br/>2 - Travelers (full black curtains used as a backdrop for concerts etc.)<br/>1 - Cyc (white curtain at the back of the stage used to project video or color)</p> <p><b>Recommendations</b><br/>Twenty-three pipe battens are guided by a large grillage “Arbor Guide Wall” built on stage left and have a payload capacity of approximately 1,300 pounds per line set. It is recommended that these be replaced with a newer counterweight system. The grillage will remain.</p> <p>Two of the battens (Main Curtain and General Purpose) have counterweights on the opposite side of the stage. These counterweights are guided by free-strung wires, which do not comply with the newest ANSI standards and exceed the recommended travel distance. Due to the necessary placement of these line sets, they cannot be incorporated into the counterweight system on stage left. There is not proper height in this location to use a manual counterweight system. It is recommended that these be replaced with motorized battens. Rather than raising and lowering the battens through manual counterweights, these battens would be automated.</p> | \$440,000 |

Twenty-five pipe battens spanning the length of the stage ceiling.

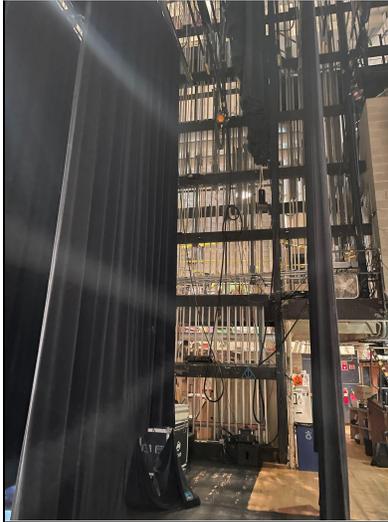
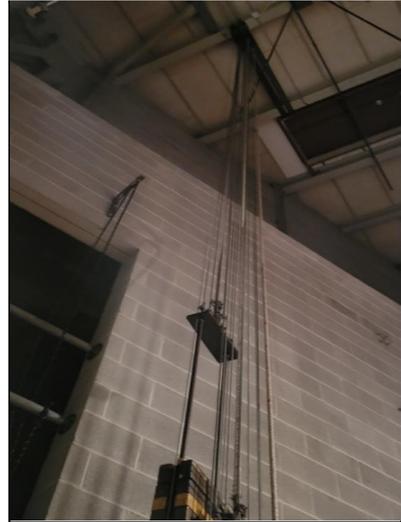
Antiquated counterweight system controlling 2 of the 25 pipe battens on Stage Right.

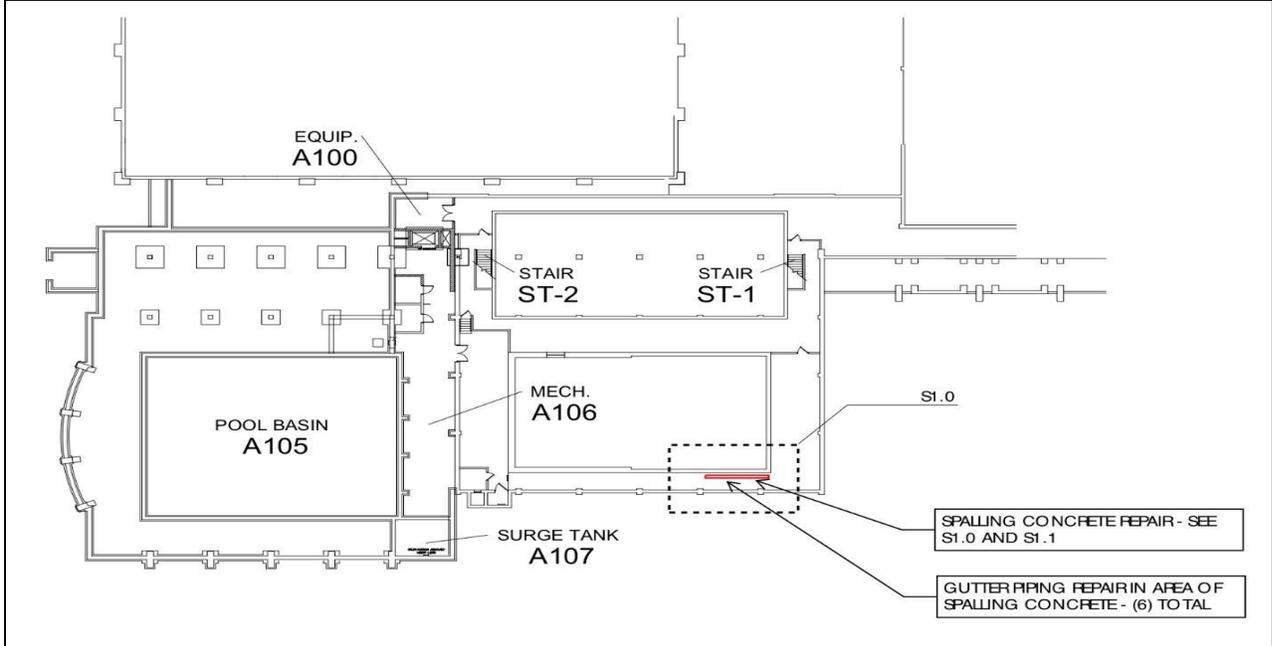
**GBN Pool Map**

| Location(s) | Project Description | Projection |
|---|---|---|
| GBN | <p><b>East Pool Structural Repair</b><br/>The east pool at GBN is the smaller, original pool and has structural issues needing to be addressed. The foundation wall near the southeast corner of the pool requires repair and structural reinforcement for a length of about 25 feet. The concrete is spalling, which exposes the rebar/reinforcement and causing corrosion. The repair will consist of the removal of all loose and damaged concrete and sandblasting of exposed rebar. In addition, a new 6” deep, reinforced concrete wall will be poured behind the existing wall.</p> <p>Additionally, the pool gutter piping near the southeast corner of the pool is</p> | \$130,000 |

| | corroding and showing signs of potential failure. It is recommended that these be replaced at the time the foundational repairs occur. | |
