**Re:** Summer 2021 Capital Projects and 3-Year Master Facility Plan

**Recommended Summer 2021 Capital Projects**

## Glenbrook High School District 225 - Glenbrook North High School (GBN) Master Facility Plan

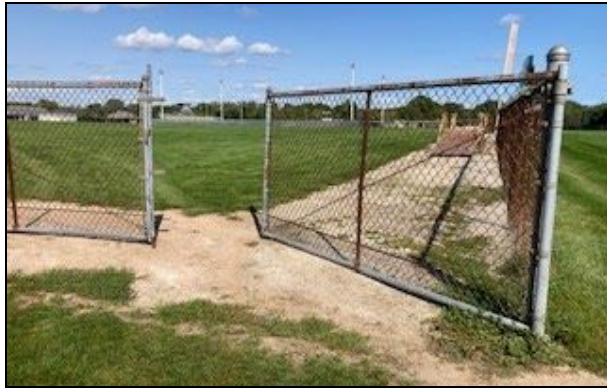
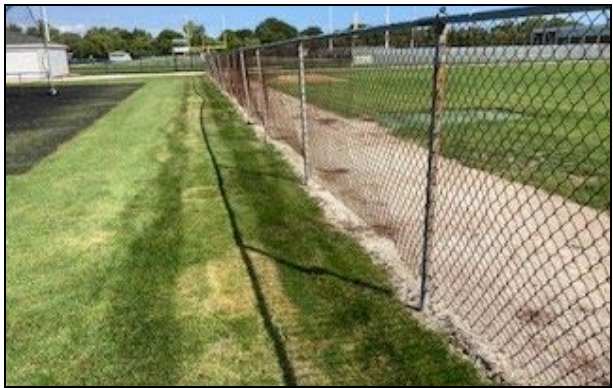
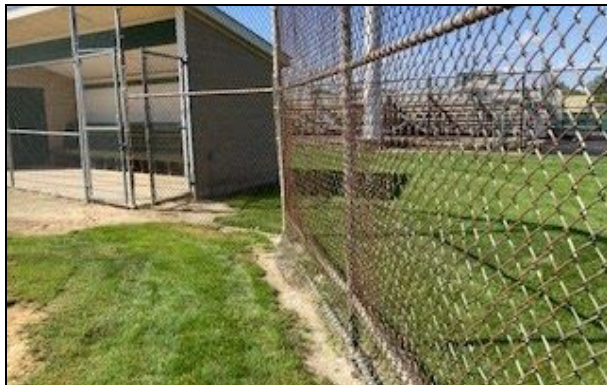
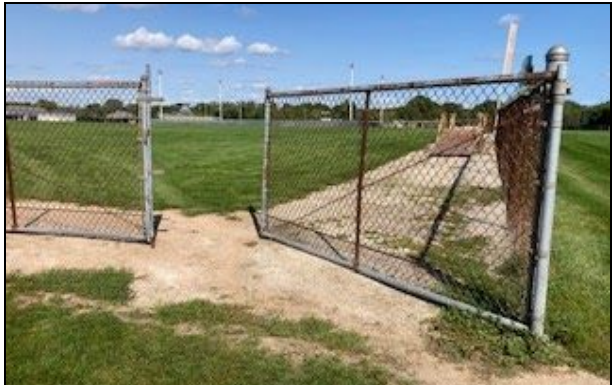
**Athletic Fencing and Netting**

GBN	<p><b>Athletic Fencing and Netting</b> The current fencing around the baseball field (1,025 linear feet) and softball field (248 linear feet) at GBN are original (50+ years old) non-coated chain link fences. The fencing has rusted, and many of the posts are heaving and lifting out of the ground. The remaining concrete posts in these areas have sharp, jagged edges that create an environment non-conducive to safe play. The metal fencing will be replaced with a black vinyl coated fence, which is consistent with all other athletic fencings at GBN.</p> <p>Additionally, considering the results of a recent safety inspection, it is recommended that a netting system be added to the softball field due to the proximity of the 1st and 3rd baselines to both the stadium bleachers and tennis courts. 50-foot high netting would anchor into a stone wall behind the home plate, and the 40-foot high net would anchor into the fence posts along the first and third baselines.</p>	\$220,000

GBN	Fencing - Baseball Field	The GBN baseball and softball fencing is original and has significant rusting. The fence is, in many places, twelve inches above the ground and concrete posts are exposed. <b>Add 50 foot netting behind the backstop and the first and third baselines recommended.</b>	\$135,000	\$135,000			
GBN	Bleacher and Press Box Replacement - Stadium	The bleachers were installed in the late 1970s. Although passing inspection, the underlying structure is slowly deteriorating and rusting. The recommended repairs due to wear and tear has been accumulating each year including seating replacement, welding and painting. The bleachers do not have proper capacity (home 1800 and visitor 900) and are the smallest bleachers in the 12 team conference. Additionally the bleachers are not ADA compliant making it difficult for students, staff and community members to watch events with friends and family. The press box is also much smaller for today's needs which include broadcasting, filming etc. <b>Replacement of bleachers, press box recommended.</b>	\$1,500,000				\$1,500,000

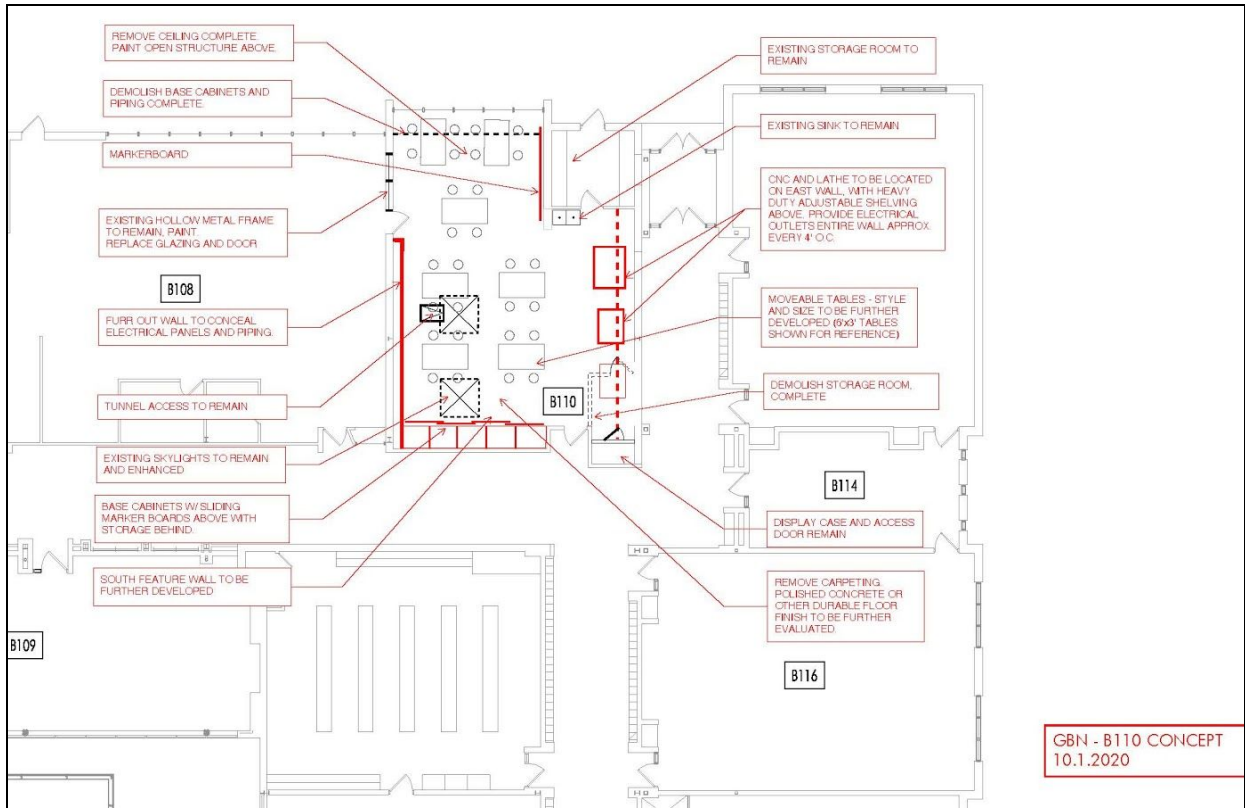
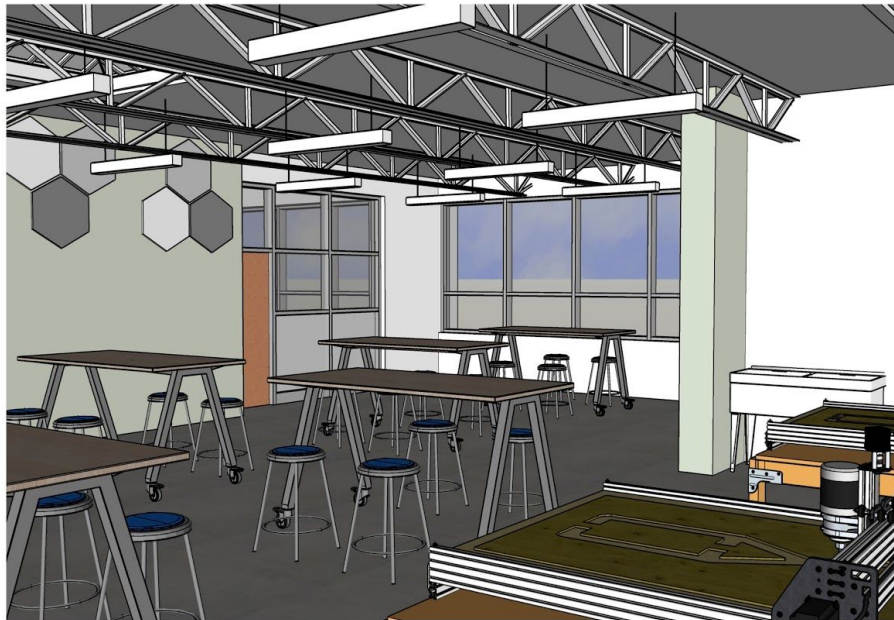
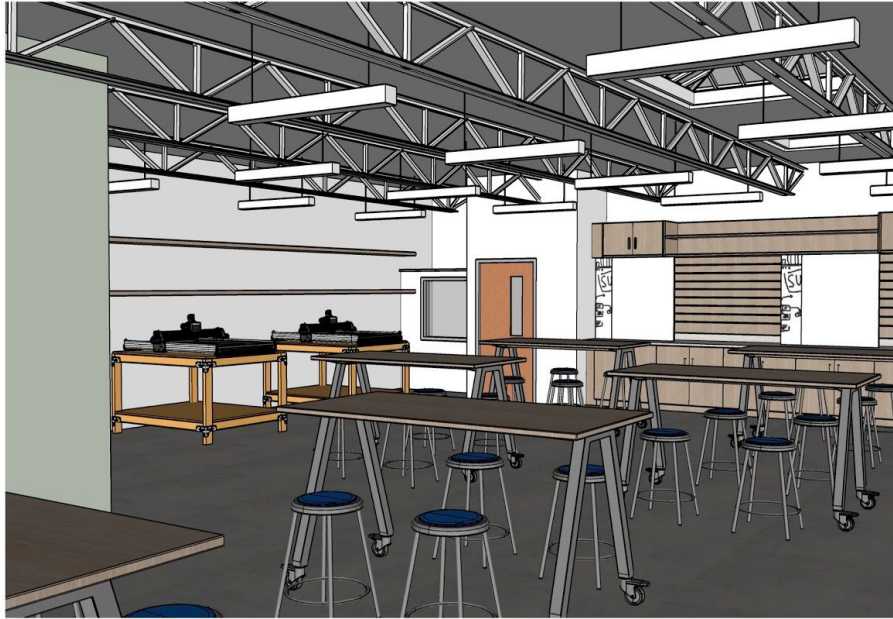
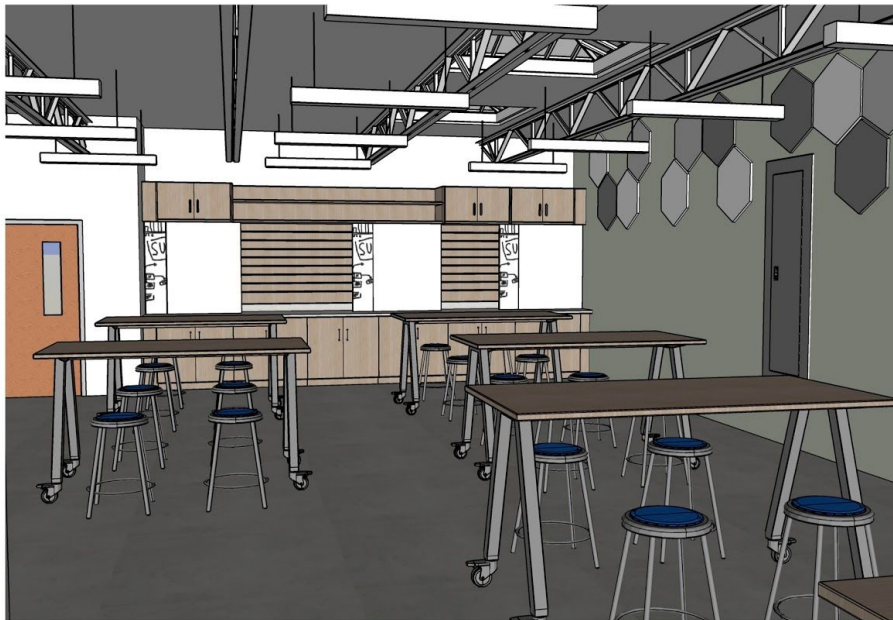
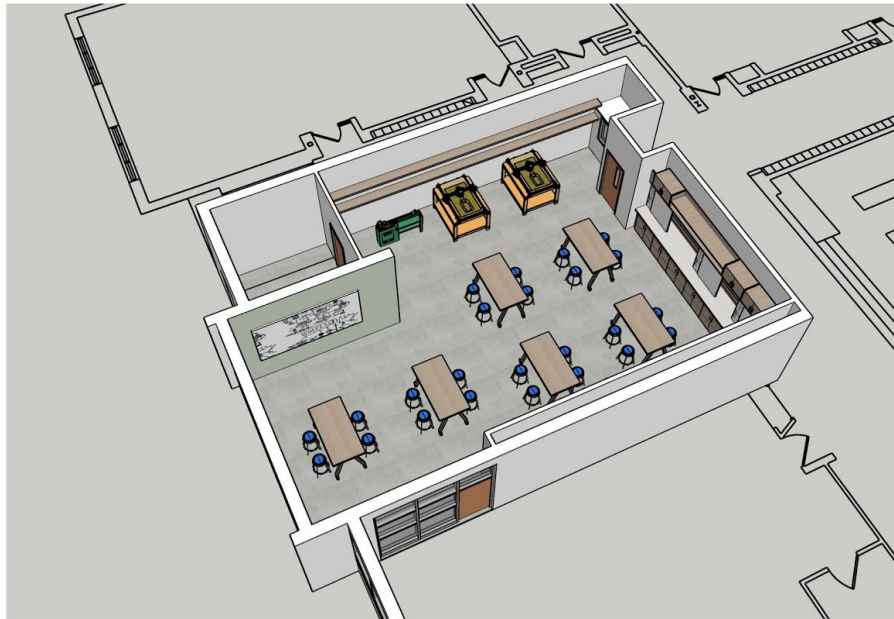
Glenbrook High Schools District 225  
Glenbrook North High School Room B110  
Project No. 20045

Location(s)	Project Description	Projection
GBN	<p><b>Career and Technical Education Classroom Renovation (B110)</b>                      B110 is an approximately 1,200 square foot classroom in the Career and Technical Education (CTE) wing. The classroom has not been updated in over 30 years. It has old carpeting that is soiled and torn, an original drop ceiling with fluorescent lighting, exposed pipes, and a storage closet no longer needed but taking up valuable space. The room has primarily been used for Sci Tech and Welding courses. The Sci Tech computer curriculum historically was taught on desktop computers and, as such, the room is still in its original configuration with heavy, individual study carrels with desktop computers. Part of the technology computer refresh plan includes replacing the desktops this year with laptop computers. Additionally, the room has several pieces of welding equipment that are no longer being used and will be replaced this year with newer technology through grant funds. Due to its configuration and the limited “project space,” the room cannot be used for the majority of CTE classes.</p> <p>The CTE courses have significantly expanded over the years, and new courses have been added through the annual curriculum review process. Over the last three years, a robust engineering sequence was added to the course list, which earns four credit hours at Oakton Community College. The courses available to students in this sequence include Introduction to Engineering Design, Principles of Engineering, Civil Engineering and Architecture, Welding 1, and Advanced Welding. The scheduling of these new courses has been difficult, and an extra classroom is needed. Renovating room B110 allows it to become a multi-purpose CTE classroom.</p> <p>The renovation scope includes removing the old drop ceiling, painting exposed ductwork, installing LED lighting, asbestos abatement, new flooring (polished concrete), and mobile furniture. The renovation will allow the room to be a maker space lab that all CTE courses (Sci Tech, Welding, PLTW, Business Incubator, Game Design, and future CTE machining/manufacturing courses) can utilize.</p>	\$245,000

GBN	Flooring - Cafeteria Hallway, Laundry Room Hallway and Main Gym Hallway	These hallways are high traffic areas and the current VCT is worn, no longer looks clean and in need of replacement. <b>Replace VCT</b>	\$160,000				\$160,000
<b>Architectural</b>							
GBN	Door Replacement - Throughout Building	The Total Doors do not always properly latch and should be replaced. <b>Replace Hallway Total Doors</b>	\$300,000				\$300,000
GBN	Reconfiguration and Furniture - Sci-Tech Room B-110	B-110 is the robotics room and needs to be reconfigured. This includes new flooring, ceiling tiles, lighting, painting and furniture. <b>Redesign of B-111 and new furniture recommended.</b>	\$245,000	\$245,000
