**Re:** Award of Bid for Summer 2022 Roofing Projects

**Re:** Summer 2022 Capital Projects and 3-Year Master Facility Plan

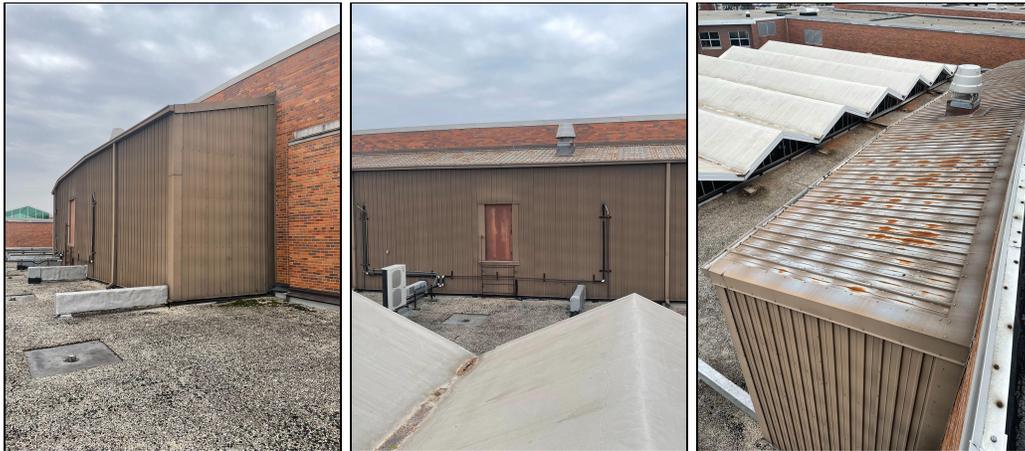
At the November 8, 2021 meeting, the Board inquired about the condition of the roof surface dated 1962 on the master roof plan illustration, which is adjacent to the GBS Auditorium House roof. At the time the auditorium was constructed, a small bump out was created to house the auditorium lighting and sound room. The sides and roof are constructed with steel siding. The roof requires very little maintenance and is not showing signs of needing to be replaced. The pitch of the roof prevents rain from pooling and its location adjacent to the higher Auditorium House roof shelters it from wind and rain. As a preventative maintenance measure, this section of roofing is scheduled to get painted this summer to address some very slight surface rusting.

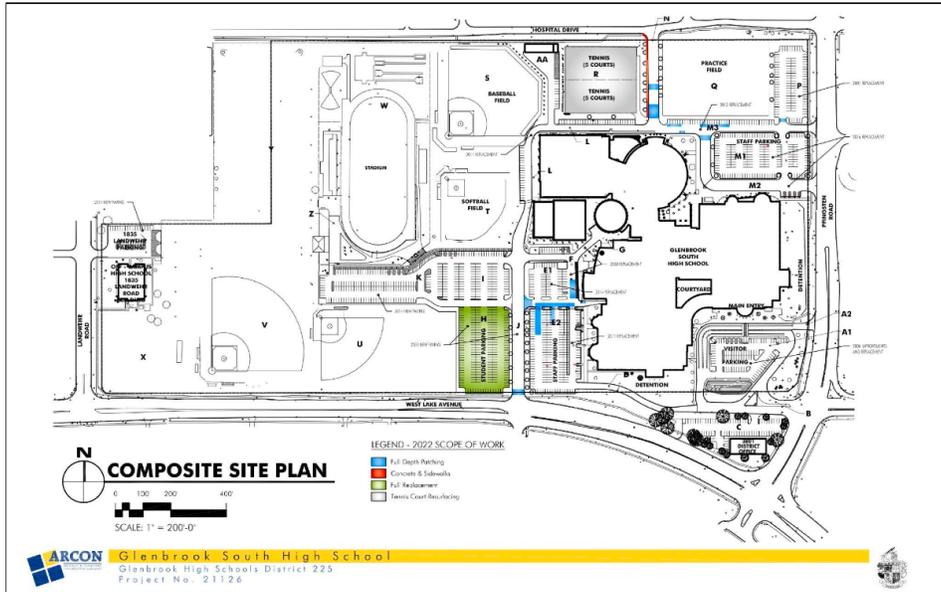
**GBS Site Work Map**

Location(s)	Project Description	Projection
GBS	<p><b>West Student Lot Replacement</b></p> <p>The district maintains a master paving schedule that plans for parking lot replacement every 15+ years and general maintenance (crack-fill and seal coating) every 4 years. The planned summer of 2022 work includes replacing the west student lot, which was last replaced in 2001, and is well beyond its useful life and showing signs of deterioration, such as alligator cracks, potholes, and crumbling, consistent with a parking lot of this age. The scope of work is to remove the existing pavement surface and binder course, remove the existing stone base and retain it on-site for reinstallation. In addition, core samples are being conducted to determine the extent of new material needed to supplement the existing stone base.</p>	\$335,000
GBS	<p><b>Deep Patching</b></p> <p>As part of the annual parking lot inspection, several areas are recommended for full-depth patching, which involves saw cutting and removing the affected area and modifying the existing stone base to accept the specified asphalt pavement cross-section. This will lengthen the life of the parking lots.</p>	\$135,000

GBS	<p><b>Sidewalk Addition</b></p> <p>Due to the limited parking capacity at GBS for students, the Glenview Ice Center sells approximately 90 parking permits to our students. In addition, there is currently a sidewalk owned and maintained by the Village that runs along hospital drive, used by students walking from the Ice Center to the GBS north entrance. However, there is currently no sidewalk connecting the Village sidewalk and the building entrance, resulting in the need for students to cut through the parking lot to enter the building. The proposed sidewalk is approximately 305 feet long and will run just east of the tennis courts, creating a safe student path.</p>	\$30,000
		<b>\$635,000</b>

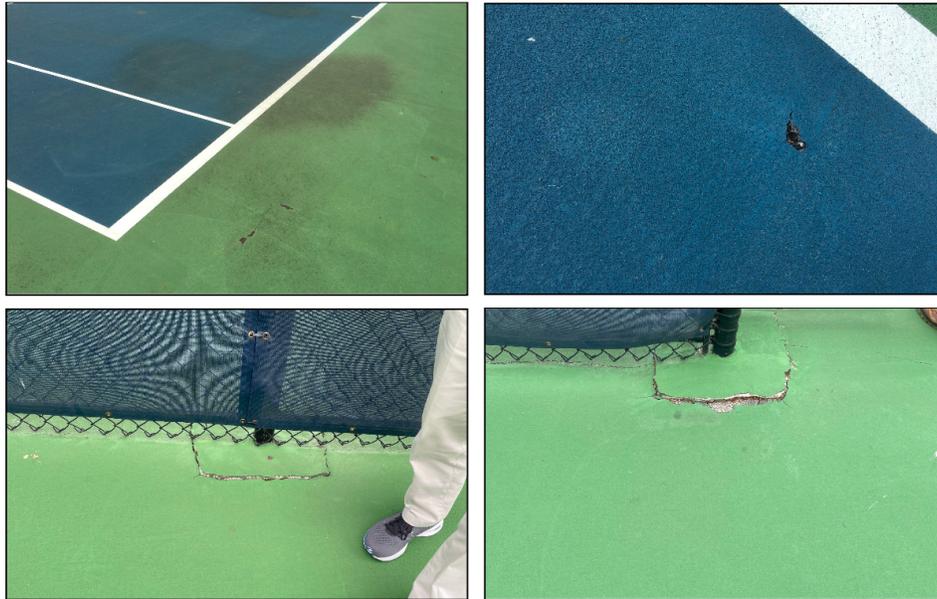
**GBS Tennis Court Images**

GBS	<p><b>Tennis Court Resurfacing</b></p> <p>There are ten tennis courts at GBS that were last replaced in the summer of 2015. As part of an overall preventative maintenance program, a resurfacing procedure is recommended every 5-7 years to restore the court's playability factors and extend the life of the courts by preserving the integrity of the asphalt court base. This summer marks year seven, and the court is beginning to exhibit signs such as minor cracking, fading, discoloration, and ponding which are indicators they are due for resurfacing. Resurfacing includes filling all cracks, leveling low spots with sand-filled asphalt, and installing one coat of liquid resurfacer and two color coats. Additionally, fence posts are heaving due to the annual freezing/thawing process. Therefore, the raised edge of concrete surrounding the fence posts will be ground to give a smooth and uniform appearance. The sealant will be compatible with the liquid track surfacing and color coats. It should be noted that tennis courts are typically resurfaced twice in a lifetime.</p>	\$135,000

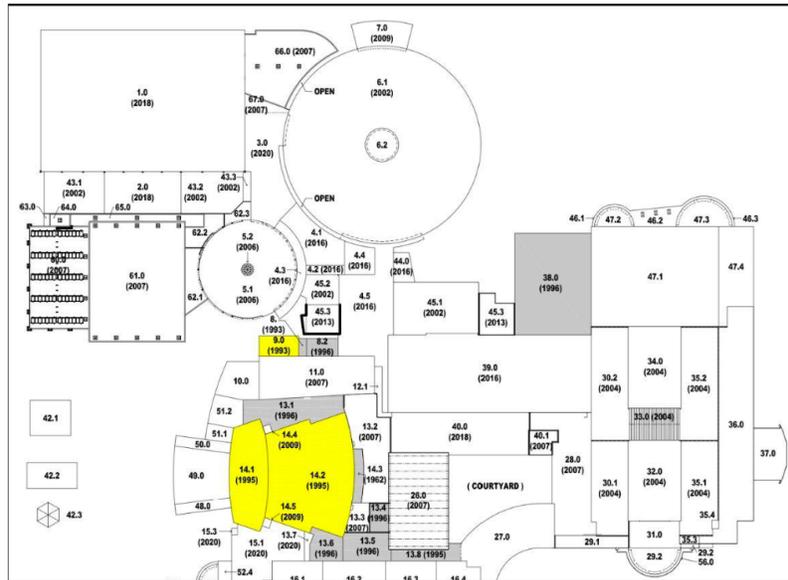
**GBS Roofing Map**

Location(s)	Project Description	Projection
GBS	<p><b>Roof Replacement - Music (Records Room)</b></p> <p>The music records room roof is the oldest roof at GBS. It is 1,000 sq. ft. and was installed in 1993. This summer, it will be 29 years old and has reached the end of its serviceable life, demonstrating several deficiencies typical for this roof system's age. The proposed new roof system will consist of roof insulation with an R-value of 30.0 minimum and a multi-ply modified bitumen built-up roof membrane with gravel surfacing. Thus, the life expectancy of the new roof is 30+ years.</p>	\$35,000
GBS	<p><b>Roof Replacement - Auditorium Stage</b></p> <p>The Auditorium Stage roof was installed in 1995 and is 5,400 square feet. This summer, it will be 27 years old and is experiencing several deficiencies typical for this roof system's age. The proposed new roof system would consist of roof insulation with an R-value of 30.0 minimum and a multi-ply modified bitumen built-up roof membrane with gravel surfacing. The life expectancy of the new roof is 30+ years.</p>	\$180,000

GBS	<p><b>Roof Replacement - Auditorium House</b></p> <p>The Auditorium House roof was installed in 1995 and is 13,800 square feet. This summer, it will be 27 years old and is experiencing several deficiencies typical for this roof system's age. The proposed new roof system would consist of roof insulation with an R-value of 30.0 minimum and a multi-ply modified bitumen built-up roof membrane with gravel surfacing. The life expectancy of the new roof is 30+ years.</p>	\$460,000
		<b>\$675,000</b>

At the October 25, 2022 Board meeting, recommended summer 2022 capital projects were discussed (see historical memo attached). In addition, as part of the District’s master roofing plan, three of the oldest roof areas at Glenbrook South are being recommended for replacement (Area 9.0 Music Records Room, Area 14.1 Auditorium Stage, and Area 14.2 Auditorium House).

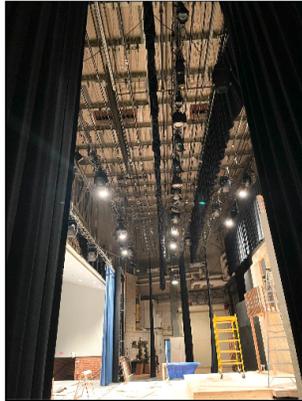
***Image 1***

Twenty-five pipe battens spanning the length of the stage ceiling.

Location(s)	Project Description	Projection
GBS	<p><b>Auditorium Rigging System Replacement</b> GBS has a manual, counterweight rigging system that is original to the auditorium (1961). This system provides the ability to lower and raise pipe battens by counterbalancing the load with an arbor loaded with counterweight (steel plates). There are 25, 76-foot long pipe battens that run across the stage's ceiling and are used to raise and lower theater equipment during a production.</p> <p><b>Breakdown of 25 pipe battens</b> 1 - Main Curtain batten 14 - General Purpose or Utility batten (scenery, special lighting) 4 - Legs (tall curtains on the side used to mask the sides of the stage) 3 - Lighting 2 - Travelers (full black curtains used as a backdrop for concerts etc.) 1 - Cyc (white curtain at the back of the stage used to project video or color)</p> <p><b>Recommendations</b> Twenty-three pipe battens are guided by a large grillage "Arbor Guide Wall" built on stage left and have a payload capacity of approximately 1,300 pounds per line set. It is recommended that these be replaced with a newer counterweight system. The grillage will remain.</p> <p>Two of the battens (Main Curtain and General Purpose) have counterweights on the opposite side of the stage. These counterweights are guided by free-strung wires, which do not comply with the newest ANSI standards and exceed the recommended travel distance. Due to the necessary placement of these line sets, they cannot be incorporated into the counterweight system on stage left. There is not proper height in this location to use a manual counterweight system. It is recommended that these be replaced with motorized battens. Rather than raising and lowering the battens through manual counterweights, these battens would be automated.</p>	\$440,000

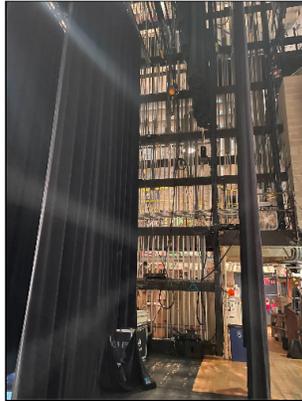
***Image 2***

Arbor Guide Wall with manual counterweight system controlling 23 of the 25 battens on Stage Left.

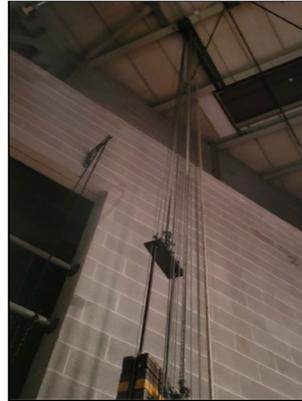
***Image 3***

Antiquated counterweight system controlling 2 of the 25 pipe battens on Stage Right.
