**Glenbrook High School District 225
Business Office**

Re: GBN Fieldhouse Floor

Date: March 8, 2016

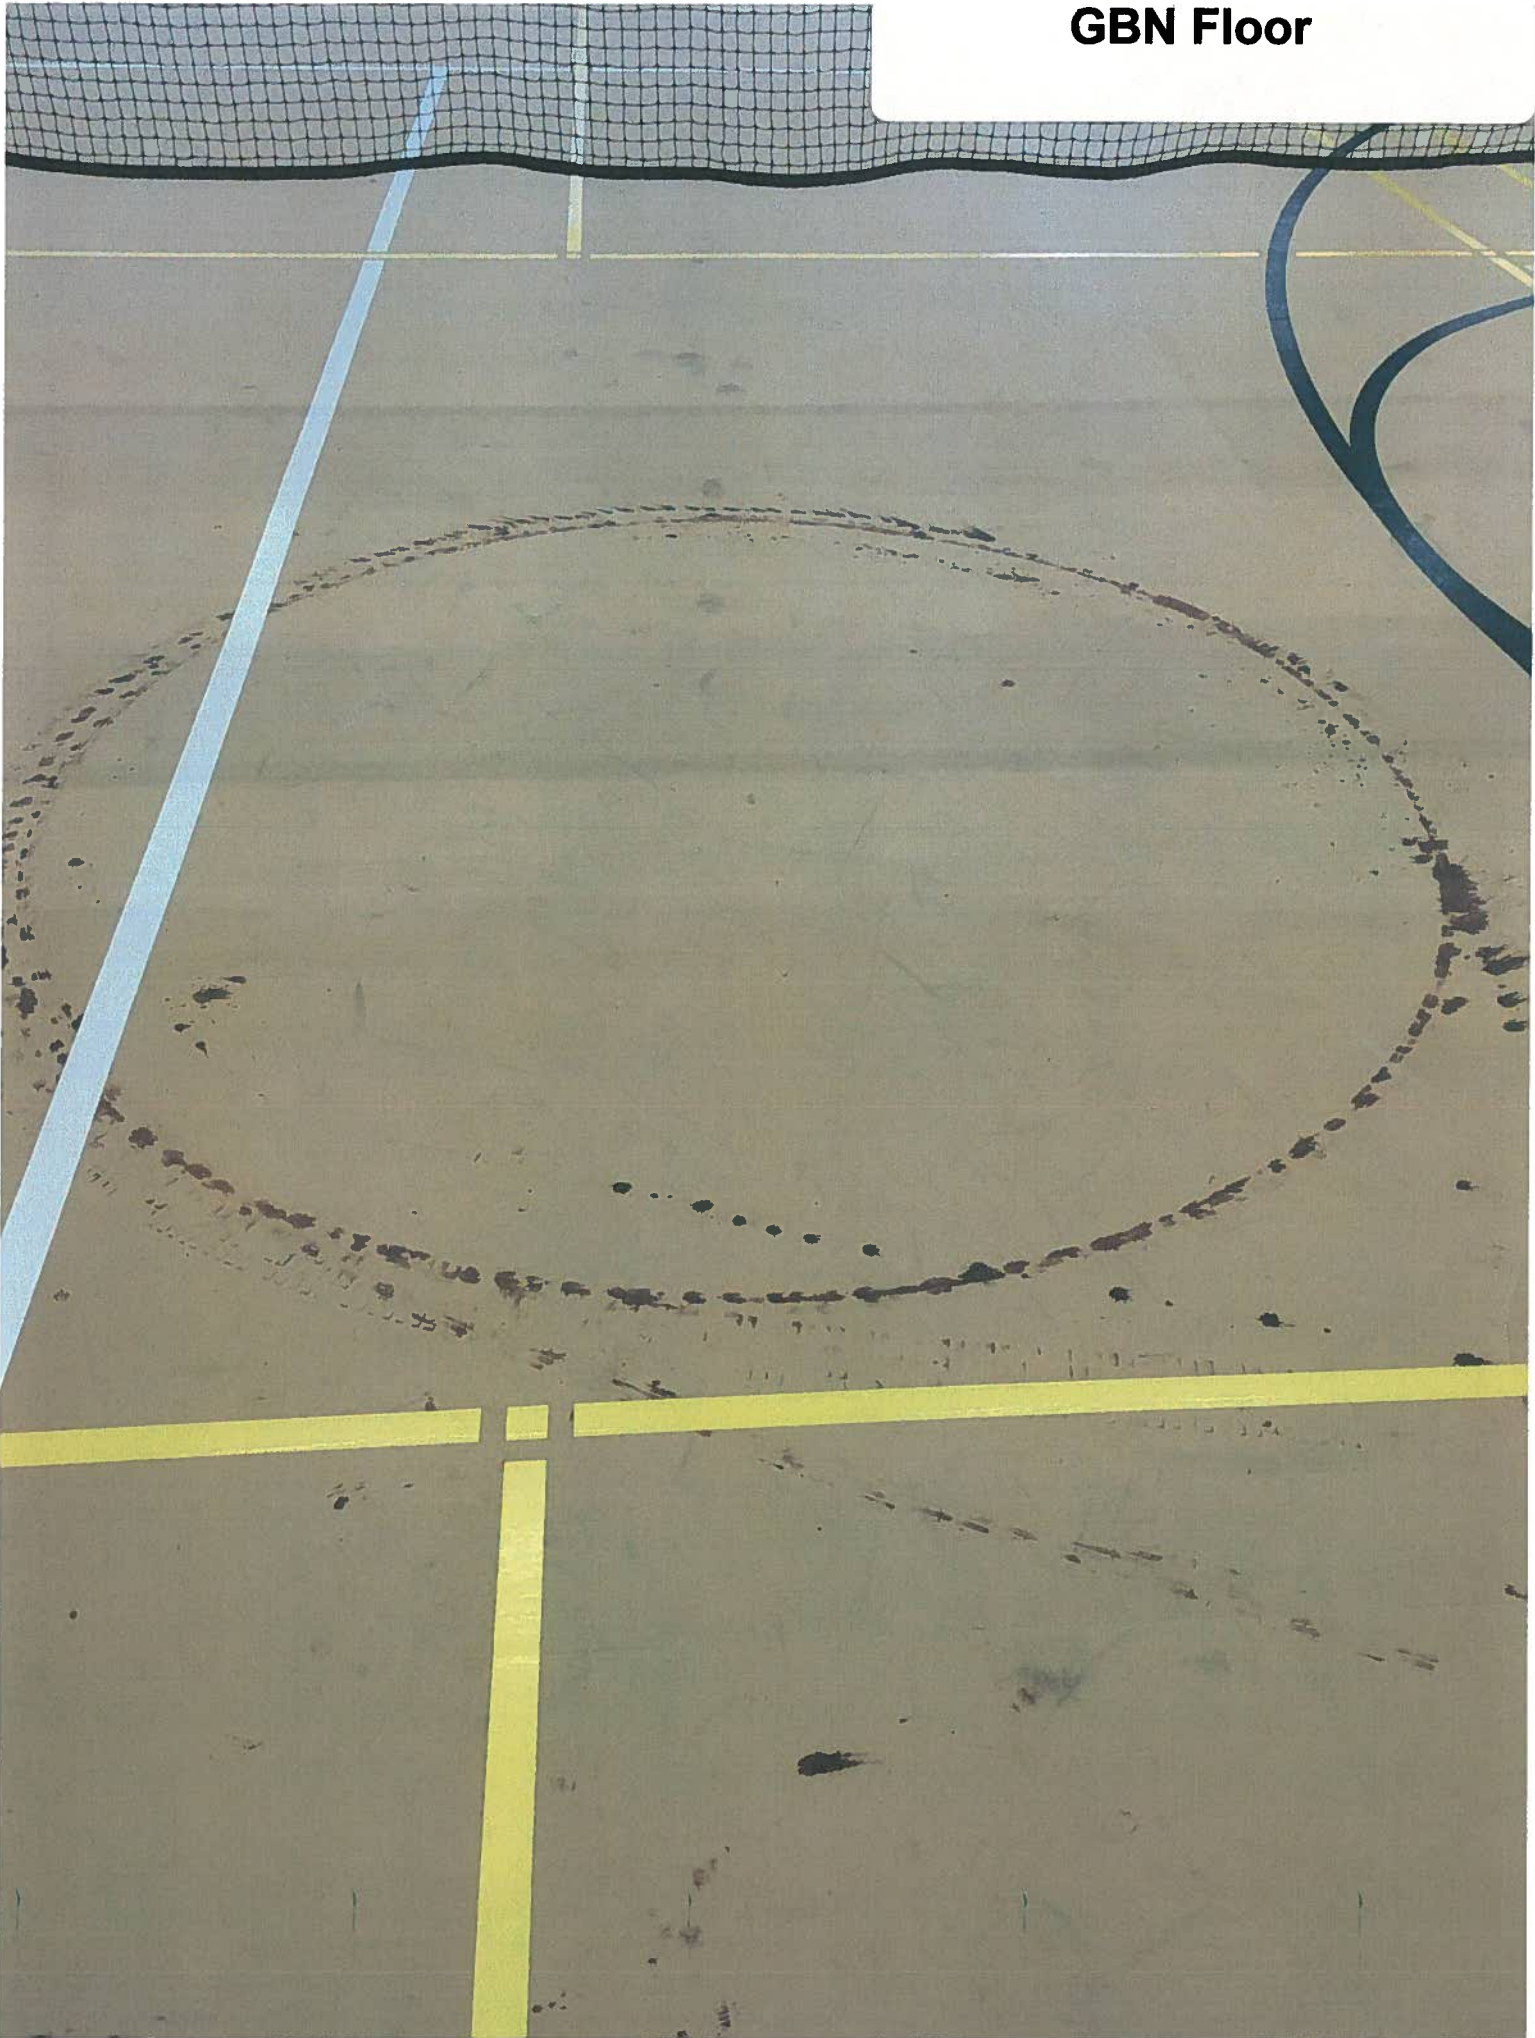
GBN Floor

There are spots throughout the fieldhouse, however the majority of damage is in the interior, tan court area where the custodian created several "circles" during the cleaning process. This area represents approximately 2.5%, or 1,000 s.f. of the floor. There are other random spots on the infield as well as the green track. The spots on the green track are not as noticeable and are sporadic in nature. Several recommended cleaning products were tried on the floor, however since the discoloration is a result of battery acid melting into the synthetic surface the spots cannot be removed or lightened. The damage is primarily cosmetic in nature and does not present a hazard of any kind.

It is recommended that an insurance claim be submitted in the amount of \$232,275 to replace the interior, court area of the Glenbrook North fieldhouse floor. The district's deductible is \$1,000. The floor was last replaced the summer of 2011 and has a 15-20 year expected life.

The interior area is 20,000 s.f. or approximately 50% of the total fieldhouse floor. The majority of noticeable damage is in this area. The interior tan area, up to the green running track, could be removed and effectively replaced at a cost of \$232,275. The track has a longer life expectancy than the interior court area, so there would not be a concern with overall life-cycle differences. This option also would not be as disruptive as a full replacement. Cost: \$232,275

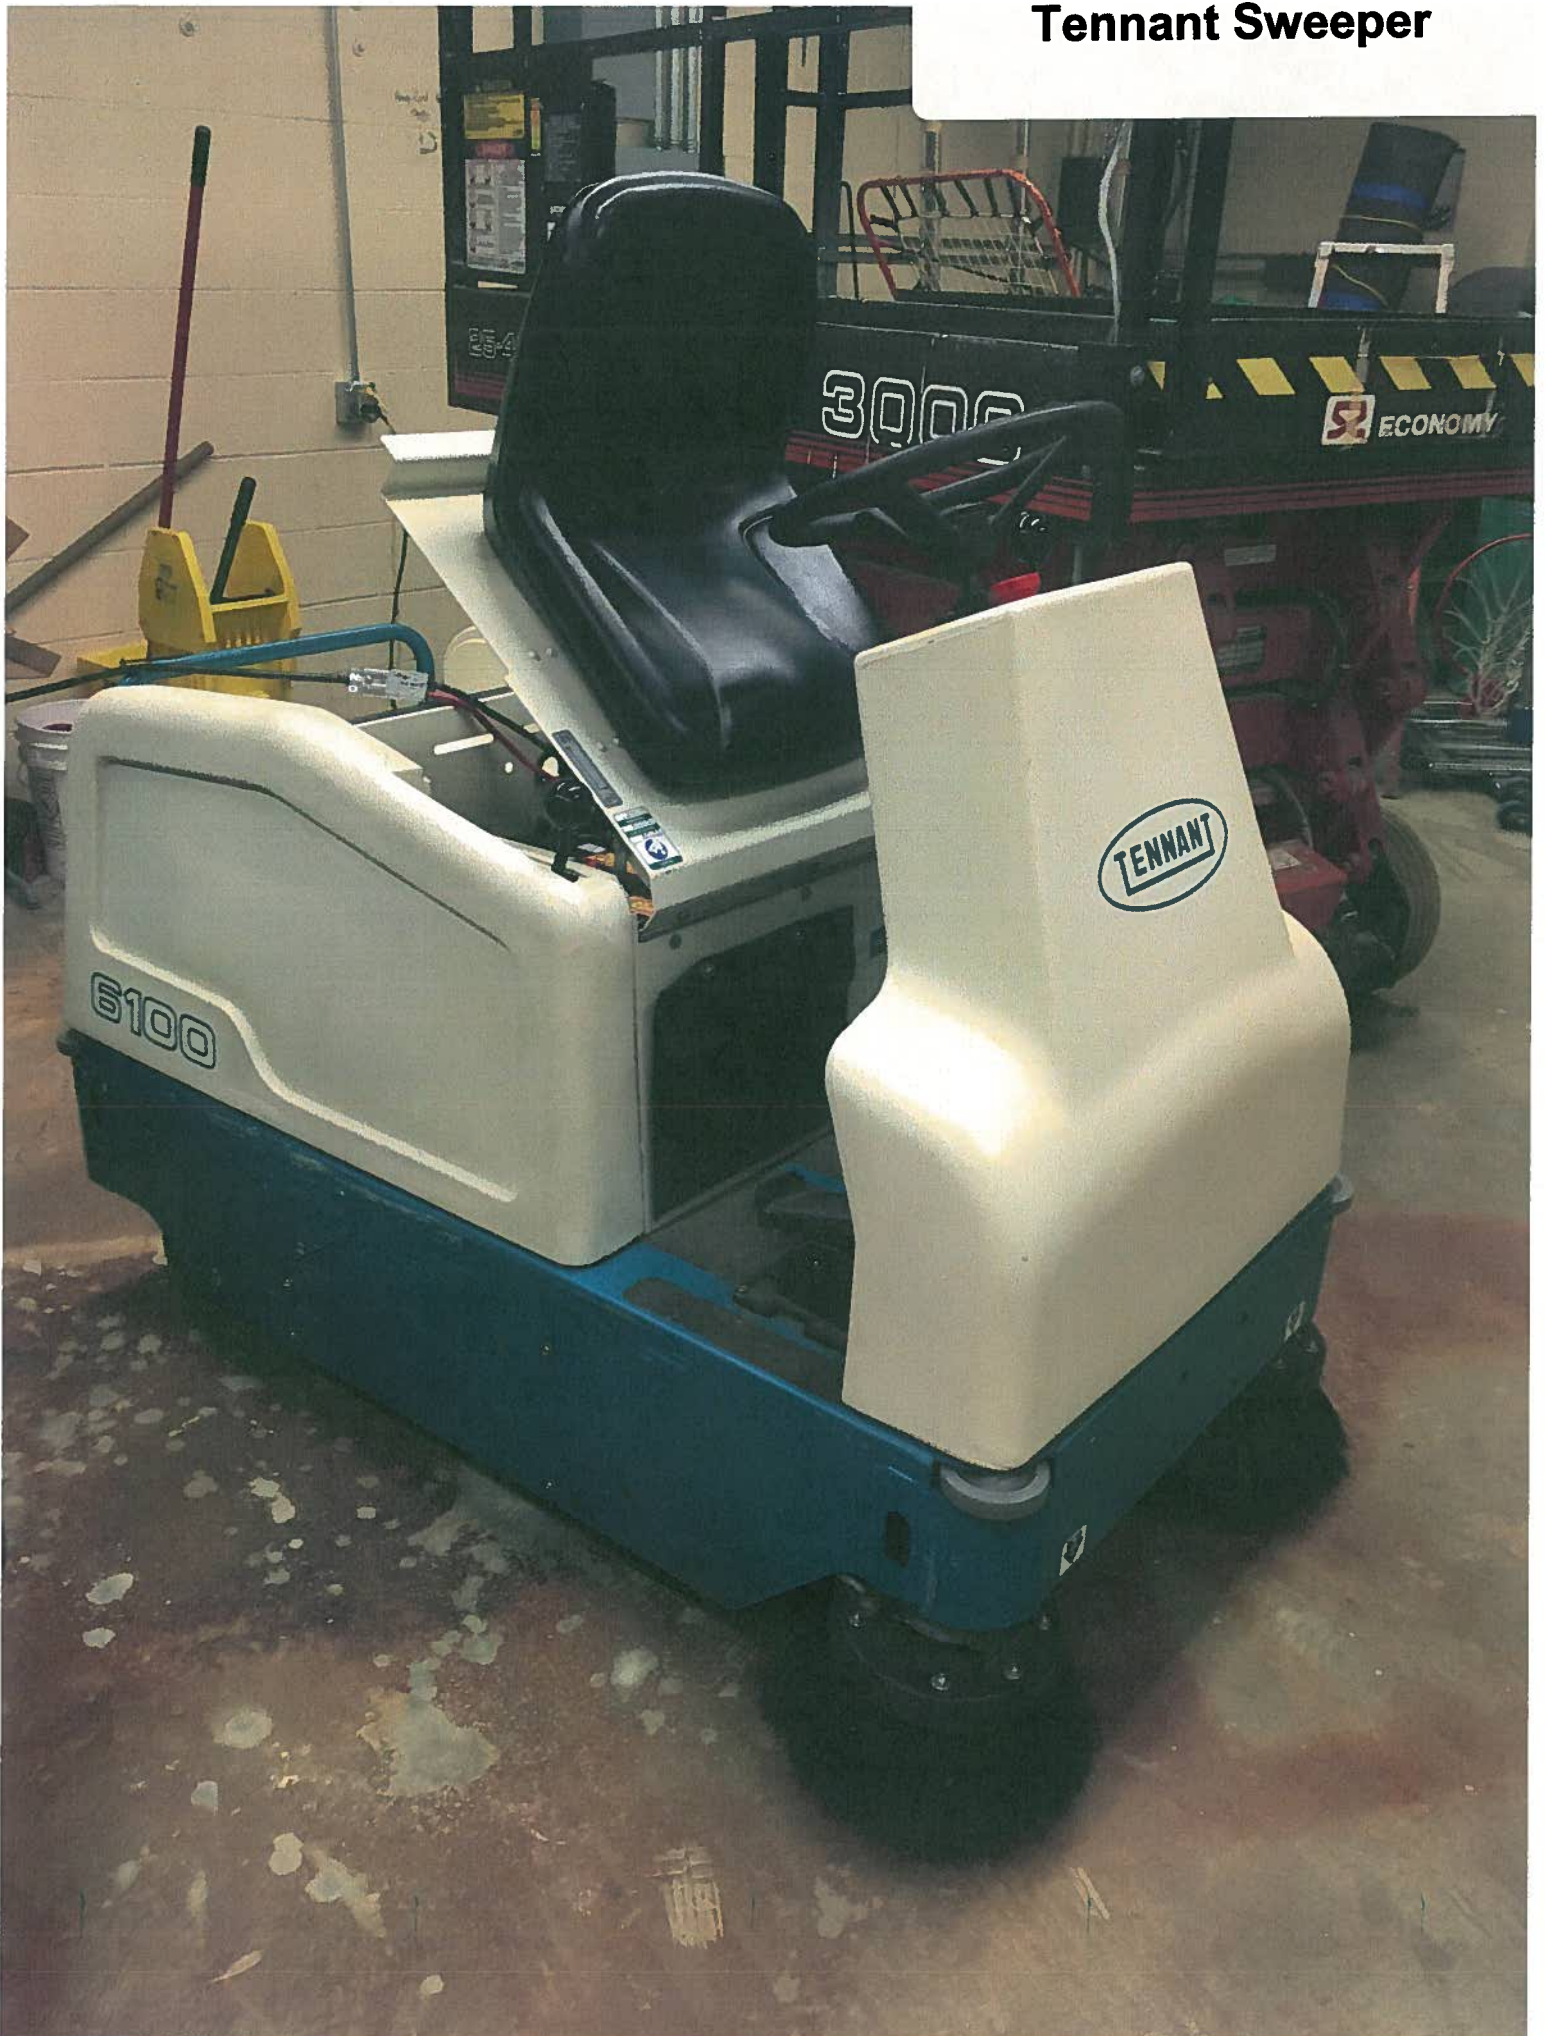
Tennant Sweeper

On Wednesday November 23, 2015, a Glenbrook North custodian was cleaning the fieldhouse floor with a "ride on" Tennant sweeper. During this routine cleaning, the machine began dripping battery acid onto the floor. The liquid was clear on contact and only darkened over time. It appears the batteries overflowed into the collection pan during the battery charging process. The collection pan filled up and dripped onto the floor during the cleaning.
