**GLENBROOK HIGH SCHOOLS  
District Business Office**

**RE: DISCUSSION/ACTION: FY 12/13 Roofing & Masonry Projects**

NORTHFIELD TOWNSHIP HIGH SCHOOL DISTRICT 225  
FIVE YEAR MASTER ROOFING AND WALL REPAIR PLAN

**ROOFING AND MASONRY REPAIR**

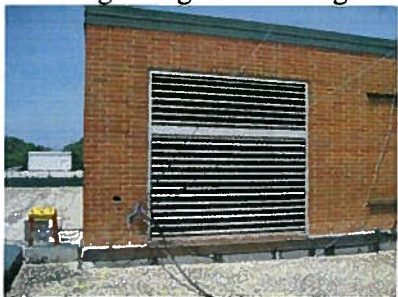
<b>GLENBROOK NORTH</b>	
<p>Areas 22.1, 22.8, 22.9 <b>PRIORITY #1</b>                      “A” Building penthouse replace wall grills and adjacent wet roof spots. The roof was replaced in 2002, however the grills were not replaced at that time. Water is infiltrating in through the grills resulting in wet spots on the adjacent roofing area.</p>

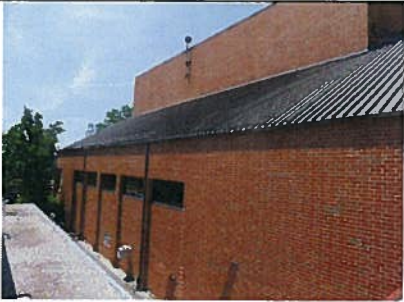
<p>\$315,841</p>
<p>Areas 27.3, 27.4, 27.6 <b>PRIORITY #1</b>                      Replace roof in CPA north and south stairs and CPA lobby. The lobby roof is original (1977). This is an area where leaks have been experienced.</p>	<p>\$172,354</p>

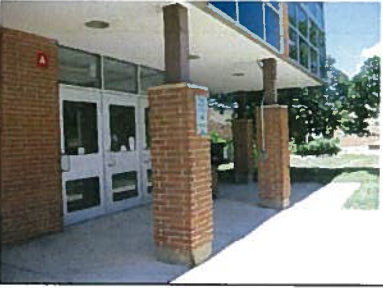
<p>Areas 22.9 and 22.8 <b><u>PRIORITY #3</u></b></p> <p>IMC Outside Portico – these are masonry column wraps in the portico outside of the IMC (northeast corner). Several of the columns are in poor condition with open stone cap joints and deteriorated manonry. The scope is to reconstruct and redesign new column wraps for better drainage.</p>		<p>\$62,400 (Alt).</p>

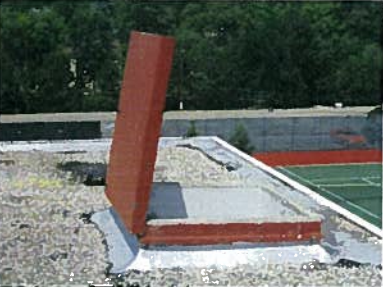
<p>Install new roof ladders at some locations; install ladder safety equipment at other ladder locations. <b><u>PRIORITY #2</u></b></p>		<p>\$42,328</p>

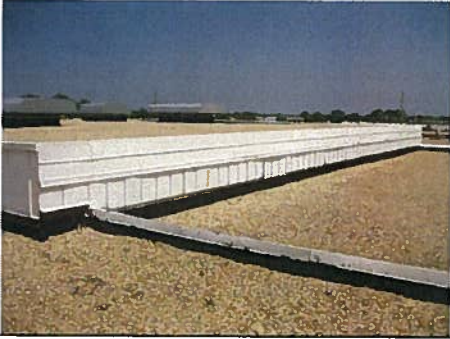
<p>Area 31.0 Foyer at 2<sup>nd</sup> floor repair metal wall panels <b><u>PRIORITY #1</u></b></p>
